### IMPROVEMENT OF WATER GATES WITH COMPOSITE MATERIAL IN **CIMANUK IRRIGATION AREA, GARUT, WEST JAVA**

Ahmad Tusi<sup>1</sup>, B.I.Setiawan<sup>2</sup>, S.K. Saptomo<sup>3</sup>, Subari<sup>4</sup>

#### Abstract

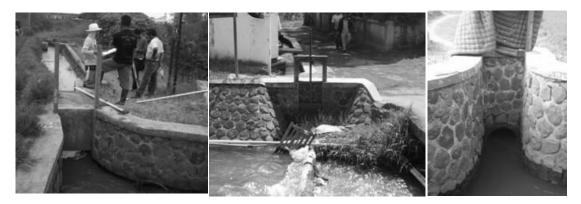
Figure 1. the Existing Condition of Division Structure

Cimanuk Irrigation Area (CIA) which is located in Garut, West Java, faces a serious problem in water allocation namely broken and lost of irrigation gates. All of the gates are made from steel which is easily corosive (Figure 1). Irrigation structures are technological artefacts which have to be operated by human beings. Thus, the water division structure (water gate) should be operated by man easily and safely. But in the field, many problems are found, for example, many gates can not be operated, because they are broken, and lost. Therefore, some solutions are needed to address the problem of water allocation and distribution to existing on-farm canals.
